# Service Bulletin

1957

NO. 330

## Studebaker and Packard Clipper

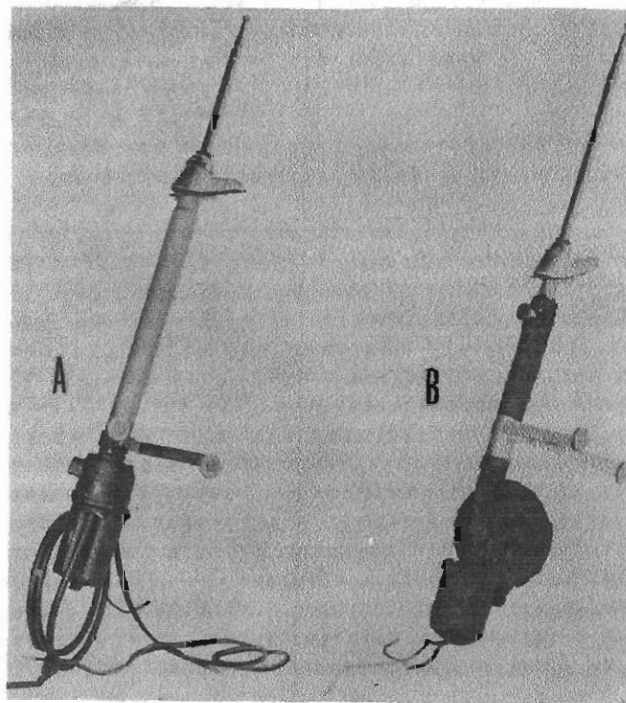
Fig. 1

The Pioneer unit, Part No. 469540, and the Casco unit, Part No. 439545, may be identified on the car through the chrome domed nut on top of the fender. The Pioneer has a domed nut

that measures approximately 1 1/16" (2,699 cm.) in diameter at its external base. The Casco nut measures approximately 1 5/16" (3,334 cm.) at its external base.

The two types are illustrated in Figure 1.

- A. Casco
- B. Pioneer

When a 57L model is equipped with the Pioneer dual antennas, service and apply the detail parts as listed in Service Bulletin No. 328 for PA-475160 when such servicing requires component parts.

When a 57L model is equipped with dual antennas of the Casco type, the following components apply:

- 439545 Antenna Assembly
- 439806 Antenna Dome Nut
- 203905 Clip
- 415772 Grommet
- 439903 Switch
- 472052 Lead-in Cable
- 1543747 Cable Extension
- G128270 Screw
- 439807 Dome Nut Insulator
- 475134 Rear Antenna Cable to Operating Switch
