# SERVICE Counselor

PACKARD MOTOR CAR COMPANY

VOL. 28, NO. 8

AUGUST, 1954

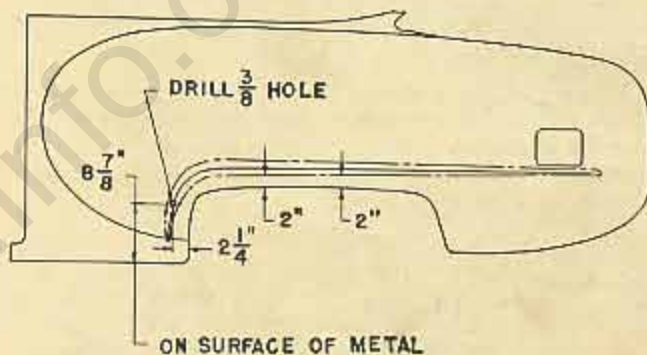
The 24th and 25th series (200 model) rear fenders had a raised crease in the metal to form a "speedline" located forward and above the fender skirt opening. The "speedline" was discontinued beginning with the 26th series cars.

A "speedline" moulding kit has been designed for attaching to the 26th series rear fender to simulate the speedline when making a rear fender or repair panel replacement on 24th or 25th series (200 model) cars.

1. The speedline moulding should be installed on the fenders before installing the assembly on the car. Make all measurements at the approximate location shown in the illustration.

2. Using a flexible scale, measure  $8\frac{7}{8}$ " upward from the lower edge of the fender and mark a horizontal line on the fender.

Measure  $2\frac{1}{4}$ " forward from the skirt opening and mark a vertical line on the fender.

Center punch the location where the lines cross and drill a  $\frac{3}{8}$ " hole through the fender.

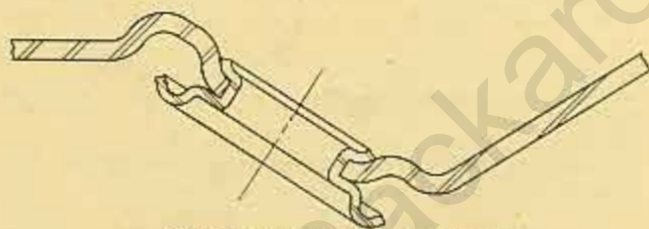
Fig. 1

SHOCK ABSORBER GROMMET GUIDE—UPPER REAR

When replacing shock absorber grommets on the above models, it is suggested that the grommet guides also be installed. It is important that the guides be installed in the upper or lower side of the brackets as shown in Figures 1-2-3-4.

3. Install the grommet guides as shown in Figures 1-2-3-4. Install the tool as shown in Fig. 5, tighten the tool nut to spread or flare the guide as far as possible. Replace the tapered spacer with the step spacer, tighten the tool nut until the flared end of the guide is flat and tight as shown in Fig. 6.

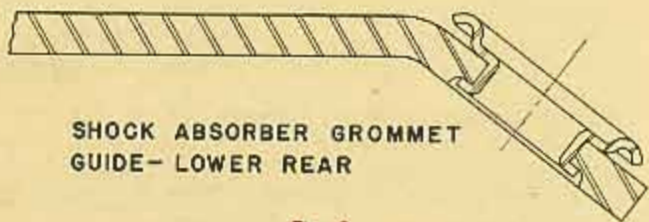
Fig. 2

SHOCK ABSORBER GROMMET GUIDE—LOWER REAR

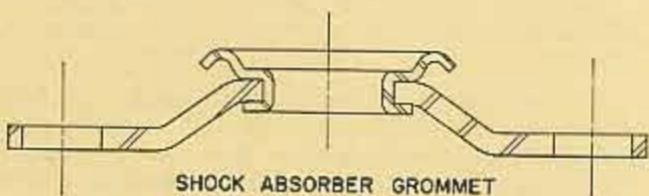
Fig. 3

SHOCK ABSORBER GROMMET GUIDE—LOWER FRONT

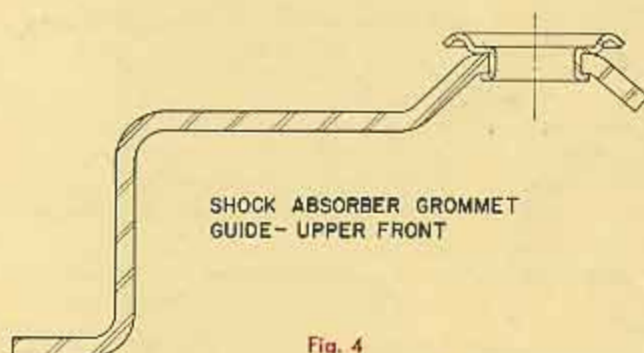
Fig. 4

SHOCK ABSORBER GROMMET GUIDE—UPPER FRONT

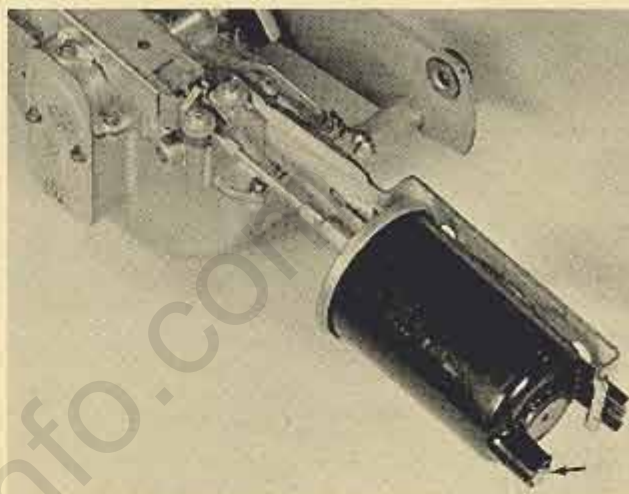
The spray jets should be adjusted to direct a stream of water on the glass slightly below the top of the wiper blades. If the spray of water is directed too high, water may run down on the cleaned portion of

the glass after the wiper blades have stopped thus creating an unsatisfactory condition.

Wiper blade strokes and water spraying time may be increased or decreased by turning the adjusting screw on the coordinator indicated by arrow in the illustration.

Turning the screw outward increases the number of strokes and turning it in decreases the number of strokes. The number of wiper blade strokes after the water spray stops is approximately the same as when the water is spraying.

**CAUTION:** Do not turn the adjusting screw in too far as the end of the screw may puncture the diaphragm in the coordinator. Usually turning the screw just a few notches will obtain the desired adjustment.
