# SERVICE C

PACKARD DIVISION

## Counselor

JULY, 1955

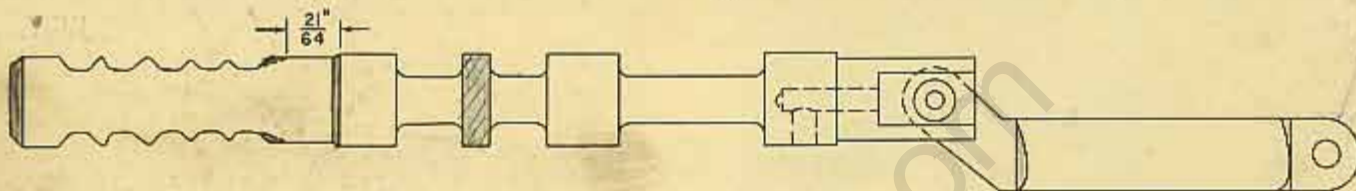
Some difficulty has been experienced in the parking lock release with the Twin Ultramatic transmission. There are two conditions that cause the parking lock to not release.

1. Difficult or unable to move the selector lever from the park position. Providing the linkage is adjusted properly and no outside interference is found, the probable cause is in the manual valve. Remove the manual valve and grind off the rear ramp of the neutral and park detent as indicated by the dotted line on the illustration.

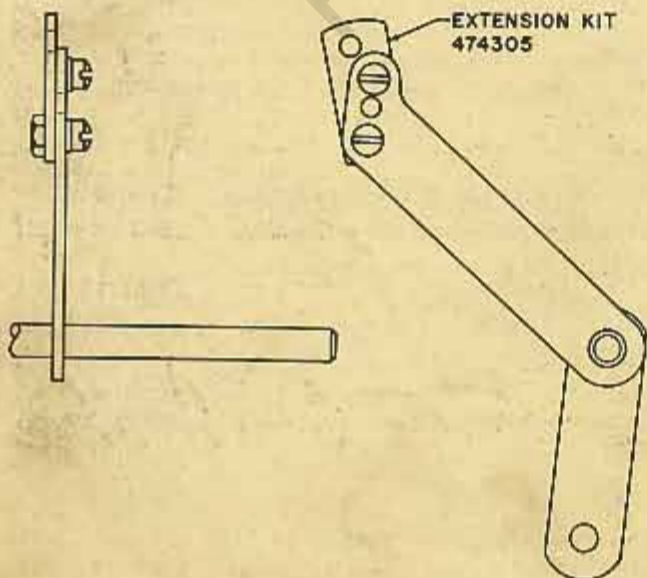
Unexpected or unwanted kick-down into low range converter when driving at full throttle or near full throttle position may be encountered in some 55th Series Twin Ultramatic Transmissions.

Because of the stack up of tolerances in throttle linkage and adjustments, throttle valve kick-down position is being reached before the carburetor throttle valves are fully open.

Therefore, to take care of the slight variations, the linkage geometry can be changed by installing

an extension on the throttle control cross shaft lever as shown in the illustration.

After installing the extension, readjust the linkage as described on pages 52 and 53 in the Twin Ultramatic Section of your new 55th Series Service Manual.

Part No. 474305 Carburetor Control Cross Shaft Lever Extension Kit is available through your Zone Warehouse.

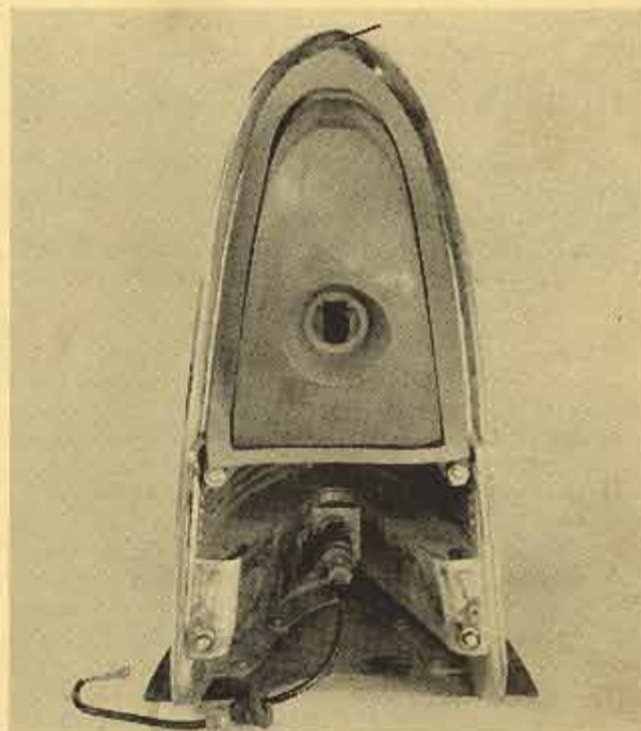
Fig. 1

Illustrated in figure 1, is a new wider tail lamp body gasket for the 55th Series Packard models which will greatly reduce dust leaks in the trunk compartment.

1. Remove the lens retainer and lens from the tail lamp assembly. Fill the upper end of the lens center

chrome bar with dum-dum as indicated by the arrow in figure 1. Fill the bar slightly below the top edge of the lens to prevent dust from entering between the lens and the bar. Reinstall the lens and retainer and cement the new gasket to the retainer as shown. Pack some dum-dum around the threaded portion of the four studs.
