PACKARD-CLIPPER DIVISION
OF
STUDEBAKER-PACKARD CORPORATION

counselor

VOL. 30, NO. 9

SEPTEMBER, 1956

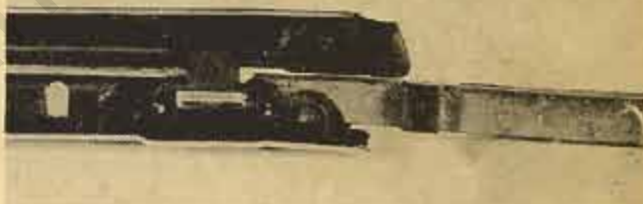
Fig. 2

Water leaks and wind noise at the forward end of the roof rail just above the front door vent window have been difficult to correct on 56th Series Hard-Top models.

2. Using a screw driver, pry up the spring at the forward end of the flipper and insert the thin end of the rubber under the spring with lip of rubber between the two halves of the flipper, see figure 2, the lip should line up with the flipper hinge pin.

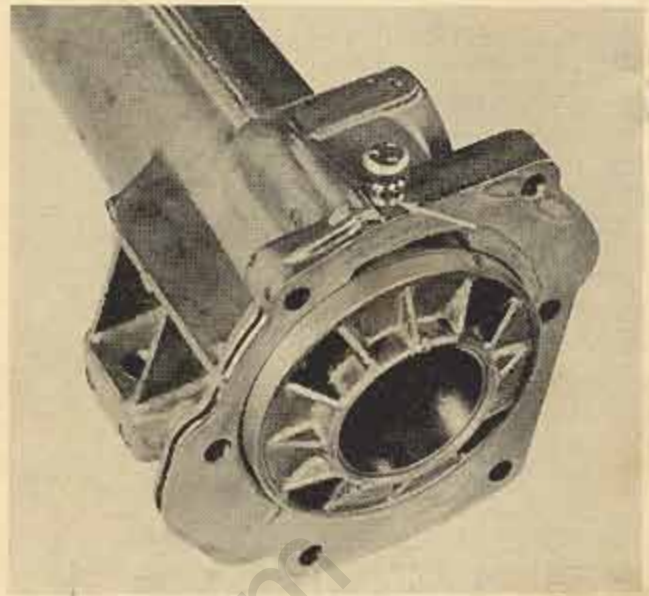
A few reports have been received of fluid leaking out of the breather on 56th Series Ultramatic Transmissions. This generally occurs with owners that accelerate to extreme high speeds in low range converter.

The most likely cause for this condition is fluid level above the recommended mark, however, in

some cases, it may be necessary to relocate the breather.

2. Drill a $21/64$ " hole through the upper part of the housing flange at the location shown in the illustration, tap out the $21/64$ " hole with a $1/8$ " pipe tap.

3. Remove the breather from the left side of the transmission and plug the opening with a $1/8$ " pipe plug.

4. Remove the upper portion of the breather from the elbow and install that portion with the cap in the tail shaft housing as shown in the illustration.

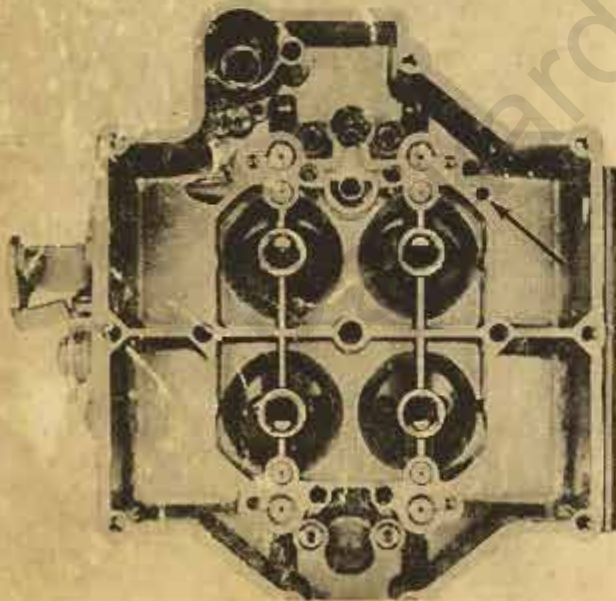
A condition which may be encountered occasionally on Model 5660 vehicles equipped with 4-barrel Carter carburetor is that of the engine cutting out or stalling on sharp left turns.

This condition can be caused by leakage of fuel from the carburetor bowl into the choke vacuum passage to cause flooding. The vacuum passage is indicated by the arrow in the accompanying illustration.

Loose bowl cover screws and nicked or dented bowl cover gasket surfaces surrounding the bores and passages can contribute to this condition.

In some instances, securely tightening the cover screws has corrected the leakage. The bowl cover inner attaching screws should first be tightened securely before final tightening of the outer screws. If the condition persists after tightening the cover screws, a tapered bushing (Carter No. 145-142) may be installed. Lightly tap the bushing until it is snug in the passage indicated in the illustration. The upper portion of the bushing will enter the mating vacuum passage in the cover when it is installed.
