Dealer 47P-32  
December 1, 1947

Subject: REDUCING HUB SHELL COVER LOSS

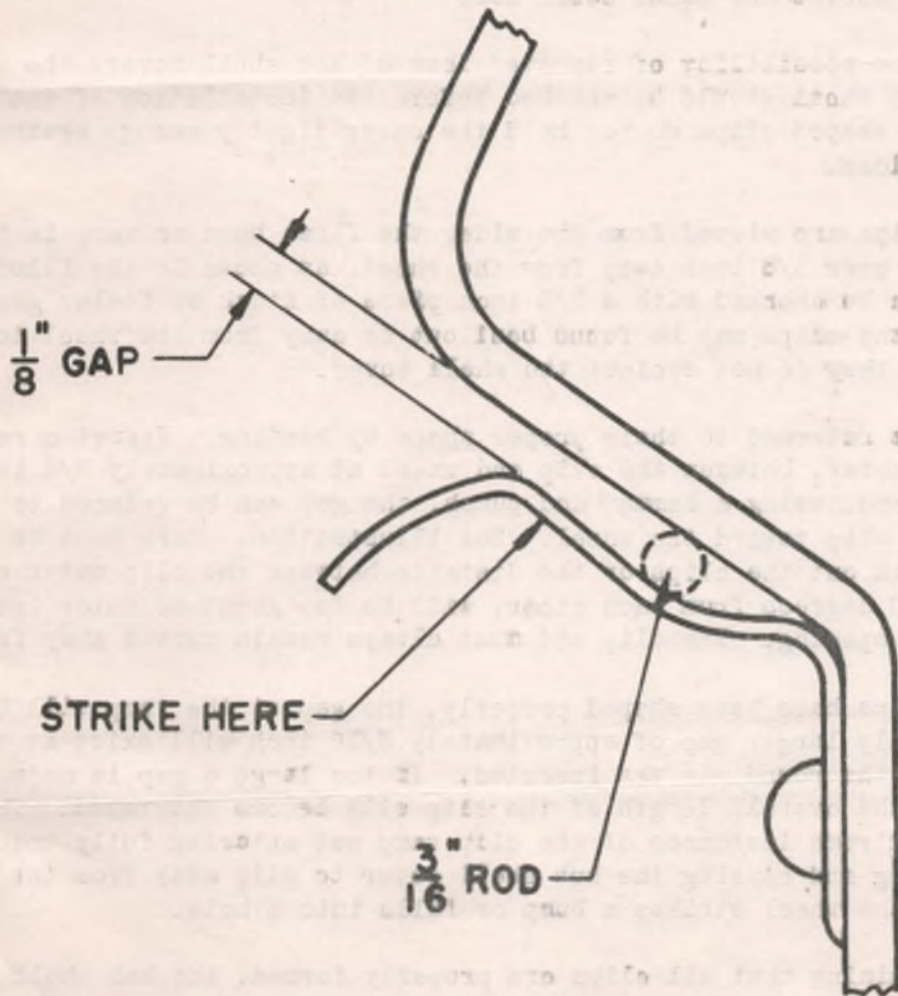
To reduce the possibility of repeated loss of hub shell covers the retaining clips on the wheel should be checked before the installation of the new cover. Incorrectly shaped clips do not hold the cover tightly enough against the wheel to prevent loss.

When the clips are viewed from the side, the first bend or ramp in the clip must not be over 1/8 inch away from the wheel, as shown in the illustration. This gap can be checked with a 1/8-inch piece of stock or feeler gauge. In some cases the clips may be found bent out or away from the wheel to the extent that they do not contact the shell cover.

When the clips have been shaped properly, the gap at the ramp will be 1/8 inch and a slightly larger gap of approximately 3/16 inch will exist at the midway point where the round pin was inserted. If too large a gap is made at the midway point, the overall length of the clip will become shortened. This may result in extreme instances of the clip ramp not entering fully into the shell cover opening and causing the hub shell cover to slip away from the clips the first time the wheel strikes a bump or falls into a hole.

Clips can be returned to their proper shape by bending. Insert a round pin, 3/16 inch in diameter, between the clip and wheel at approximately 3/4 inch from the first bend and, using a hammer and punch, the gap can be reduced to 1/8 inch by driving the clip toward the wheel. See illustration. Care must be exercised not to straighten out the clips or the distance between the clip outer ends, when measured 180 degrees from each other, will be too great to enter into the hub shell cover opening. The clip end must always remain curved away from the wheel.

After determining that all clips are properly formed, the hub shell cover opening must be centered over and contacting all clips uniformly before pushing the hub cover in place. A cocked cover temporarily held in place by a clip or two will be lost when the wheel is jarred by the road surface.
