Packard **SERVICE TECHNICAL** **Bulletin**

Dealer 47T-36

December 22, 1947

Subject: HEADLIGHT WIRING CAMPAIGN

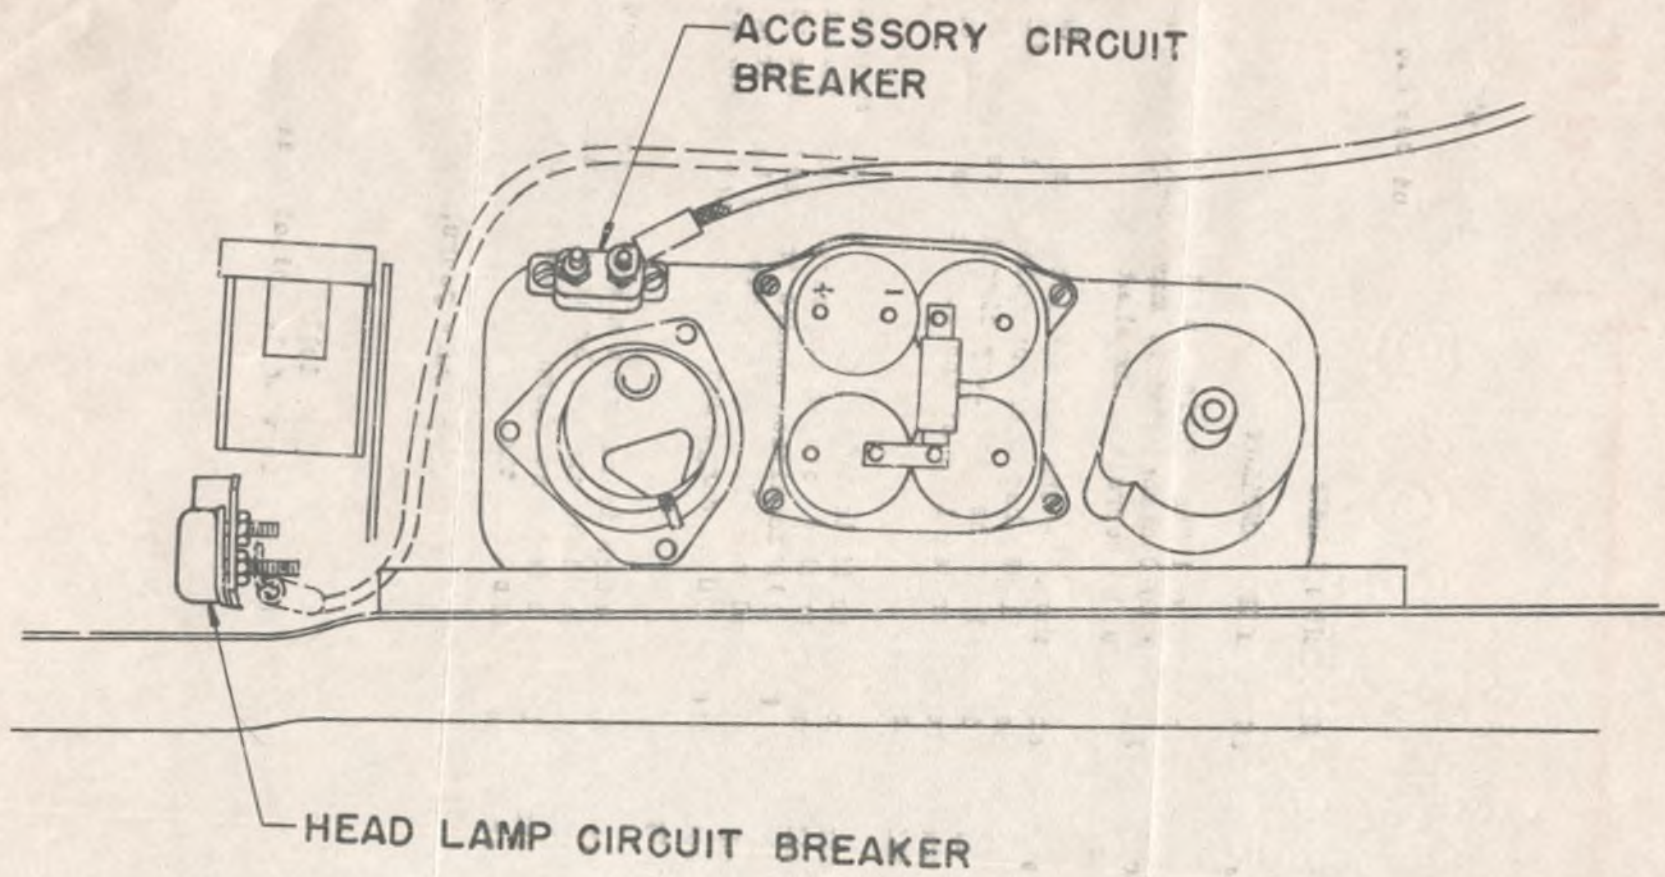
The body feed cable, shown in the October 1st issue of the Service Counselor as No. 61-RW, has been connected to the headlight circuit breaker instead of the accessory circuit breaker. This causes the entire electrical load of the body to be thrown onto the headlight circuit.

It is possible to put sufficient load on this circuit to cause the headlight circuit breaker to open the circuit extinguishing the headlights. When this condition occurs the headlights will go on and off in a regular cycle. This cycle may be as long as five seconds, which would be dangerous when the car is operated at high speeds.

This body feed cable, which is red with a white tracer, should be removed from the headlight circuit breaker and attached to the accessory circuit breaker as shown in the illustration on the reverse side of this bulletin.
