Packard SERVICE TECHNICAL Bulletin

55T-37
Dealer 28
July 29, 1955

Subject: TORSION-LEVEL SUSPENSION LOAD ARM SNAP - 55TH SERIES

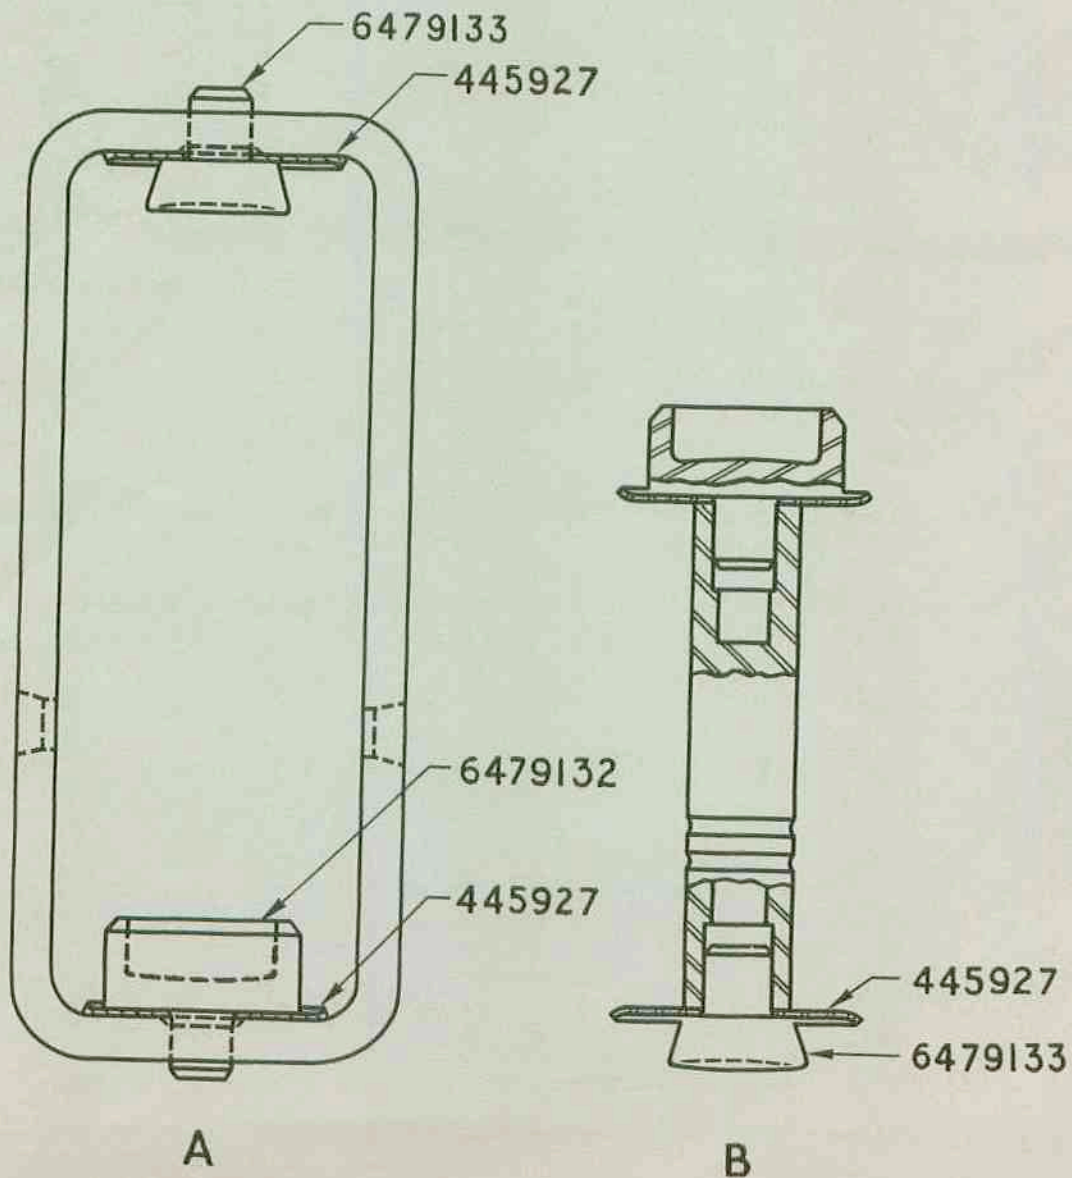
A snap or clicking noise may be heard occasionally in the Torsion-Level Suspension under full jounce or rebound of the car. In other words "when the body moves upward."

The direction of force on the rear load arms and links is always downward, therefore, when weight is removed from the passenger or trunk compartment or the body raises on rebound, the rear link upper ball studs sometimes shift on their seats causing the snap.

The rear load arm link upper ball studs have been redesigned, having a slight concave contact surface which prevents the slight shift on rebound. These new studs started in production on the following vehicle numbers: 5542-7358, 47-6761, 62-8210, 67-6978, 82-8926, 87-6739, 88-1376. The ball seat in the lower part of the link has been changed slightly and should be replaced while replacing the upper ball stud.

Should you encounter a snap in the front suspension that is definitely in the front links, install the new type rear ball studs, part number 6479133, in the lower end of the front links. See illustration "B."

2. Remove the two bolts that attach the load arm link to the torque arm and remove the link assembly.
3. Press or drive out the ball stud from the upper part of the link and install the new stud, part number 6479133, in its place. See illustration "A."

Press or drive out the ball seat from the lower part of the link and install the new seat, part number 6479132, in its place.

1. Install the Front Load Arm Link Removing Tool J-6065 and remove the front link.
2. Clamp the link in a vise and using a blunt chisel carefully drive out the lower ball stud by driving downward on the seal retainer above the stud.
3. Install a new seal retainer if necessary when installing the new ball stud.
4. Place some special lubricant in the ball stud seats and reinstall the links. Remove the Load Arm Link Tool.
