# Service Bulletin

NO. 325

## Studebaker and Packard Clipper

STUDEBAKER-PACKARD CORPORATION  
SOUTH BEND 27, INDIANA

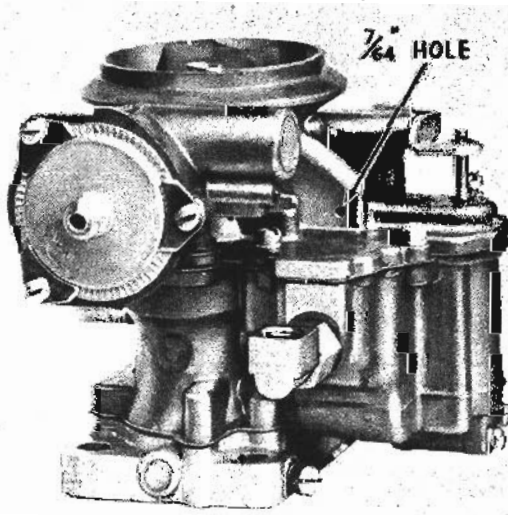
Fig. 1

On a complaint of hard starting or prolonged cranking to start a hot engine on models equipped with a supercharger, modifying the carburetor and air chamber cover as outlined below will provide considerable improvement.

1. Remove the carburetor air chamber cover and remove the carburetor from the engine.
2. Drill a  $7/64$ " hole into the vent passage at the location shown in Fig. 1. Then, drill two  $5/64$ " holes in the throttle body at the locations shown in Fig. 2. It is not necessary to disassemble the carburetor to drill the holes but care should be taken to prevent chips from entering the carburetor.
3. If the air chamber cover does not have a

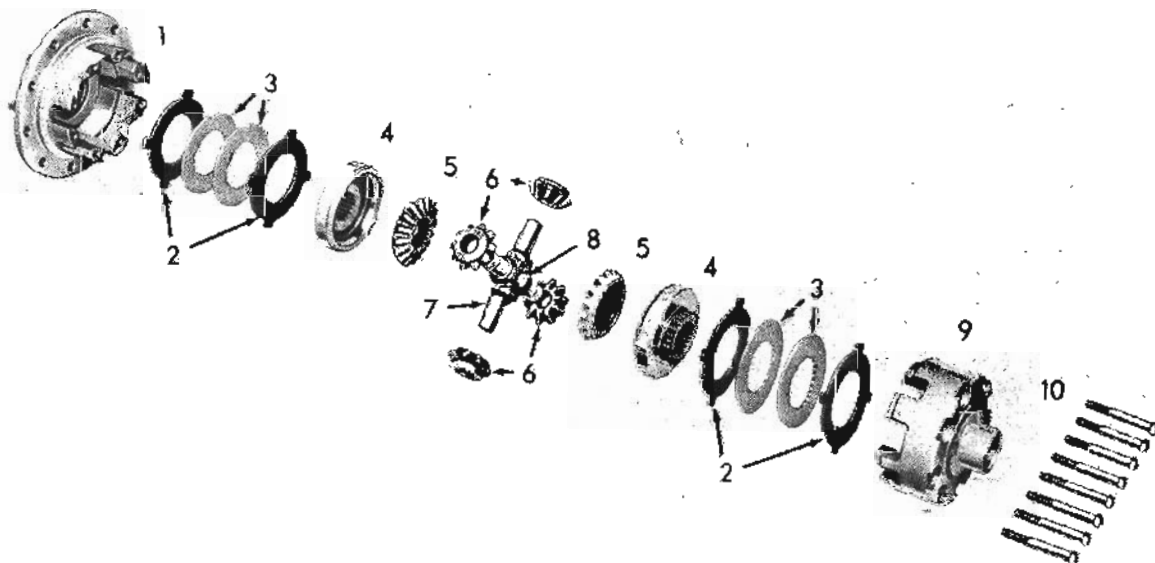
A change has been made in the Twin-Traction differential; the cone-type clutches have been replaced by disc-type clutches. Fig. 5 illustrates the exploded view of the latest type.

The disassembly and reassembly procedure with the exception of the clutches is the same for both types. When reassembling the disc type, the lugs of the plates are placed in the notches provided in the housing. Note the relationship of the discs to the plates; the two friction discs are placed between the plates.
