Service Bulletin

NO. 348

Studebaker and Packard

REVIEW OF ENGINE OIL RECOMMENDATIONS

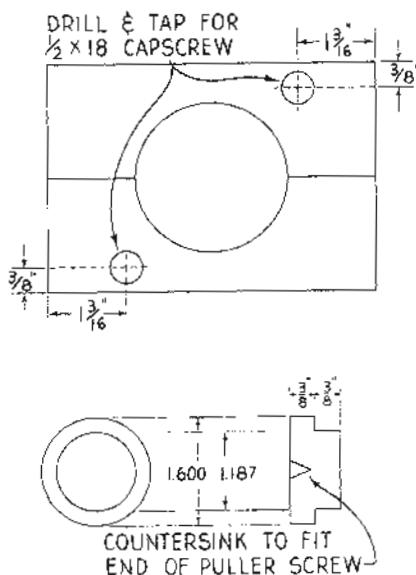
Fig. 1

The Pinion Rear Bearing Remover J-5365 can be modified so that it can be used as a differential side bearing remover.

Drill and tap the Remover tool for a 1/2"-18 thread at the locations shown in Fig. 1.

To remove the side bearing, install the Remover tool on the side bearing. Place a centering or adapter plug in the end opening of the differential. If a suitable adapter plug is not available, one can be made to the dimensions shown in Fig. 1.

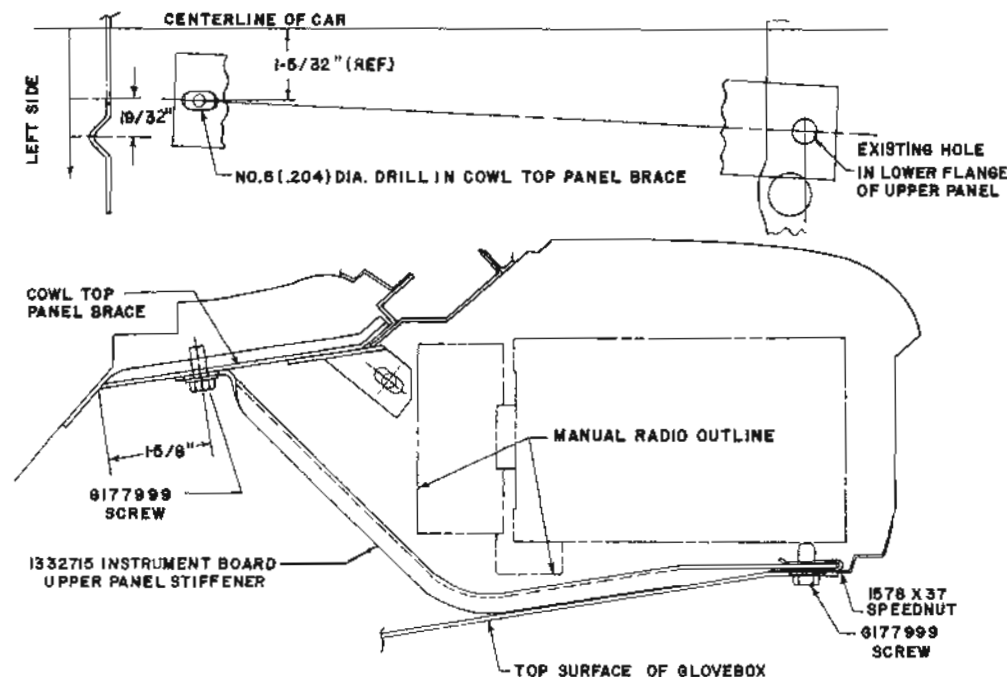
Fig. 3

To provide increased stability of the instrument board panel, a stiffener brace entered production starting with Serial Nos. 59S-80105 and 59V-30318.

The brace, installed as shown in Fig. 3, may easily be installed in cars before the above serial numbers. The brace will reduce instrument board movement and assist in preventing squeaks, buzzes and rattles caused by excessive instrument board movement.

To install, first remove the glove compartment box. It is not necessary to remove the radio in cars so equipped. Place the flat end of the brace on the upper opening flange for the glove box at the first hole to the left of the door catch and install the Screw, Part No. G177999, and Speednut, Part No. 1578X37. Using the brace as a template or the dimensions given in Fig. 3, mark and drill a 3/16" hole in the cowl top panel brace and install Screw, Part No. G177999. Install the glove compartment box.

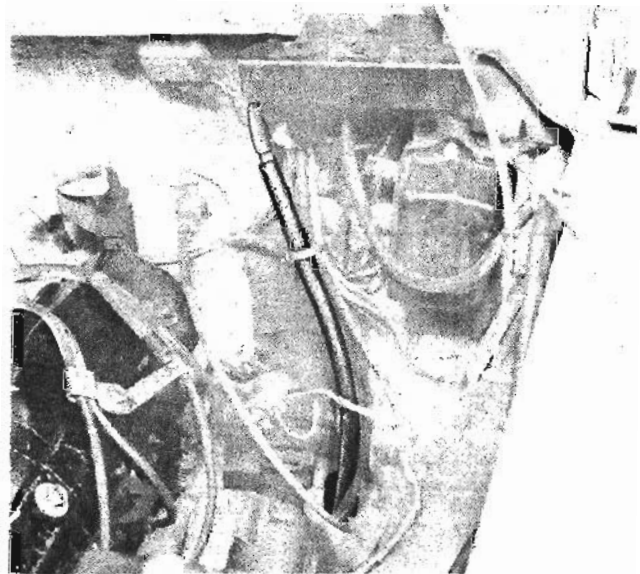
FIG. 4

STARTER CABLE-TO-ACCELERATOR LINKAGE INTERFERENCE - 59V Lark Models

To prevent possible interference between the starter motor cable and the accelerator linkage, the starter switch-to-starter motor cable has been lengthened and rerouted on 59V Lark Models. This change entered production with Serial No. 59V-26047.

Note cable routed through
body hold-down bracket

The improved routing of the cable is shown in Figure 4, 5 and 6.

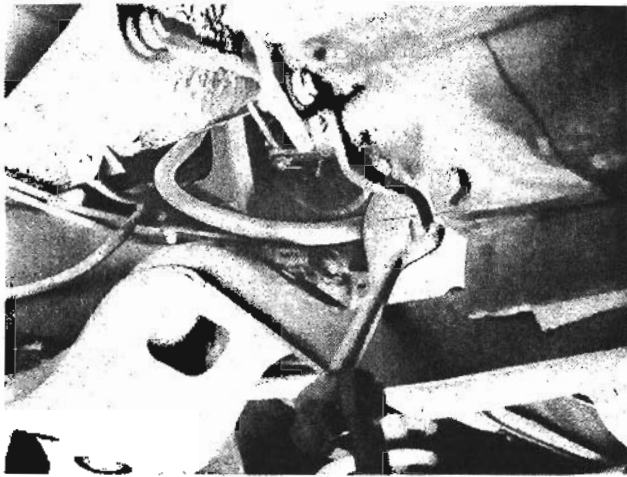
Fig. 5 - Car with OD and Power Steering. Clutch Operating Shaft removed to show cable.

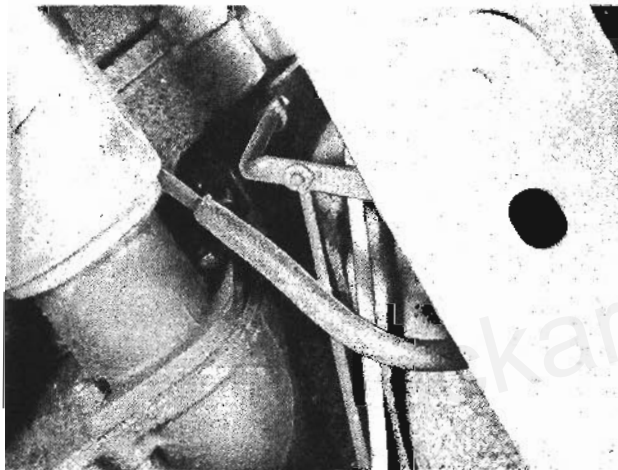
Fig. 6 - Car with Automatic - Note position of Cable in respect to throttle linkage.

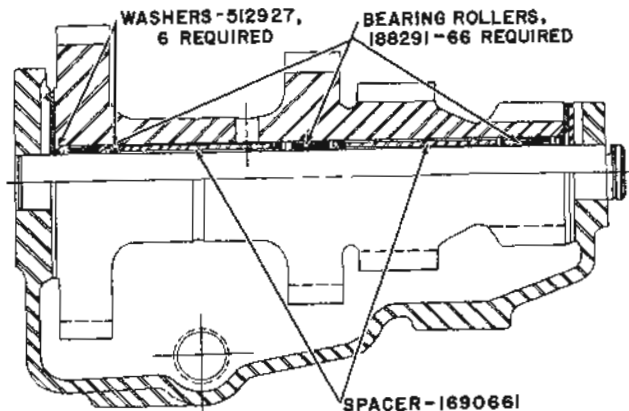
FIG. 7

Beginning with the following serial numbers, a center bearing has been added to the countershaft of the T90B transmission.

This improvement can be incorporated in transmission of trucks having serial numbers prior to those listed above. Remove the long spacer and install two short Bearing Spacers, Part No. 1690661 with 22 additional bearing rollers, Part No. 188291, and two washers, Part No. 512927, between the two spacers in the center of the countershaft. See Fig. 7.

As an alternate, you may cut the long spacer into two sections 2.079" (2-5/64") long and then install the necessary additional bearings and washers.
