PACKARD

Service Counselor

VOL. 22, NO. 2

FEBRUARY 1, 1948

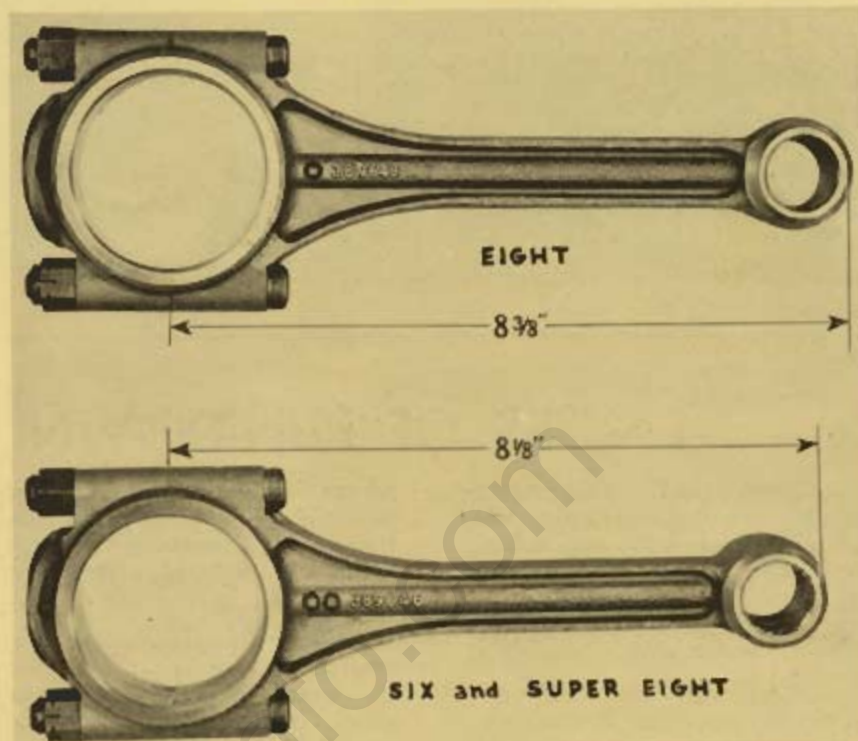
The connecting rods used in the Six and the Super Eight are interchangeable. However, these rods are not interchangeable with those used in the Eight due to their difference in length. The rods used in the Eight measure $8\frac{3}{8}$ inches from the rod and cap split line to the top of the piston pin bushing bore. The rods used in the Six and Super Eight measure $8\frac{1}{8}$ inches from the split line to the top of the bushing bore. (See accompanying illustration.)

When a Super Eight rod (the shorter rod) is installed in an Eight engine, the compression of that particular cylinder will be lowered resulting in a weak cylinder. This is due to the fact that the piston will be approximately $\frac{1}{4}$ -inch below the top of the cylinder block, instead of flush with the top, when the piston reaches its upward limit of travel. If an Eight rod (the longer rod) is installed in a Super Eight engine, the piston attached to that rod will travel upward beyond its normal limit and will strike the bottom of the cylinder head. When this condition exists, considerable damage may be done when attempting to start the engine. This is especially true if the rod is starting its downward stroke permitting the engine to build up torque before the piston is pushed up against the cylinder head.

Connecting rods now being used in production may be identified by the part number which is forged in the I-beam section of the rod and by the number of spherical segments or "pimples" below the part number. These identification marks also are shown in the accompanying illustration. The rods used in the Six and Super Eight engines carry part number 389646 and have two "pimples". Rods for the Eight engine carry part number 389648 and have one "pimple".

Early production Six and Super Eight engines were equipped with connecting rods having only one "pimple" instead of the two now being used to facilitate identification. These rods may be identified either by the part number 389646 forged in the rod or by the $8\frac{1}{8}$ -inch dimension measured from the split line to the top of the piston pin bushing bore.

When replacing connecting rods in a Six, Eight, or Super Eight engine, care should be exercised to insure installing the proper rods in the particular engine being serviced. This also holds true when replacing a crankshaft in an Eight or Super Eight engine.

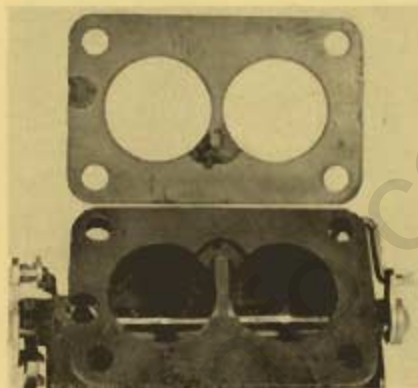
An inspection may show that the upper and lower gaskets are not in their proper location but are interchanged. When these gaskets are interchanged, the lower gasket swells and restricts or closes off the vacuum passage in the car-

buretor. The accompanying illustration shows a carburetor and a lower gasket which was installed above the insulator block instead of below the block. You will note that a portion of the gasket had swelled and had bulged up into the pocket around the vacuum passage opening, thereby closing the opening.

When the vacuum passage is closed off the vacuum piston is held in its uppermost position by the vacuum piston spring. The metering rods which are linked to the vacuum piston also are held in their uppermost position.

Having reviewed what takes place when the vacuum piston and metering rods are functioning normally, the trouble caused by a closed vacuum passage is readily apparent. The vacuum piston cannot be drawn downward regardless of the amount of vacuum available and the metering rods are held in their raised position. This provides a rich or power mixture even though an economy mixture is desired.

If the gaskets are found to have been interchanged, the carburetor should be removed and the gaskets installed in their proper location. It is not necessary to disassemble or service the carburetor since the vacuum piston will resume operation when the vacuum passage is again opened.

The gaskets may be identified in that the upper gasket has a woven pattern while the lower gasket is plain or smooth. The upper gasket has a perforated steel core covered with graphited asbestos anchored to the core on both sides. The lower gasket is of compressed graphited asbestos only.

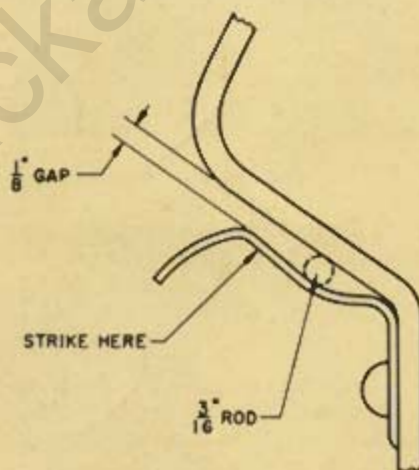
To reduce the possibility of repeated loss of hub shell covers, the retaining clips on the wheel should be checked before the installation of the new cover. Incorrectly shaped clips do not hold the cover tightly enough against the wheel to prevent loss.

When the clips are viewed from the side, the first bend or ramp in the clip must not be over $\frac{1}{8}$ inch away from the wheel, as shown in the illustration. This gap can be checked with a $\frac{1}{8}$ inch piece of stock or feeler gauge. In some cases the clips may be found bent out or away from the wheel to the extent that they do not contact the shell cover.

Clips can be returned to their proper shape by bending. Insert a round pin $\frac{3}{16}$ inch in diameter between the clip and wheel at approximately $\frac{3}{4}$ inch from the first bend and, using a hammer and punch, the gap can be reduced to $\frac{1}{8}$ inch by driving the clip toward the wheel. See illustration. Care must be exer-

cised not to straighten out the clips or the distance between the clip outer ends, when measured 180 degrees from each other, will be too great to enter into the hub shell cover opening. The clip end must always remain curved away from the wheel.

When the clips have been shaped properly, the gap at the ramp will

be $\frac{1}{8}$ inch and a slightly larger gap of approximately $\frac{3}{16}$ inch will exist at the midway point where the round pin was inserted. If too large a gap is made at the midway point, the overall length of the clip will become shortened. This may result in extreme instances of the clip ramp not entering fully into the shell cover opening and causing the hub shell cover to slip away from the clips the first time the wheel strikes a bump or falls into a hole.
