SERVICE Counselor

PACKARD DIVISION

STUDEBAKER-PACKARD CORPORATION

AUGUST, 1955

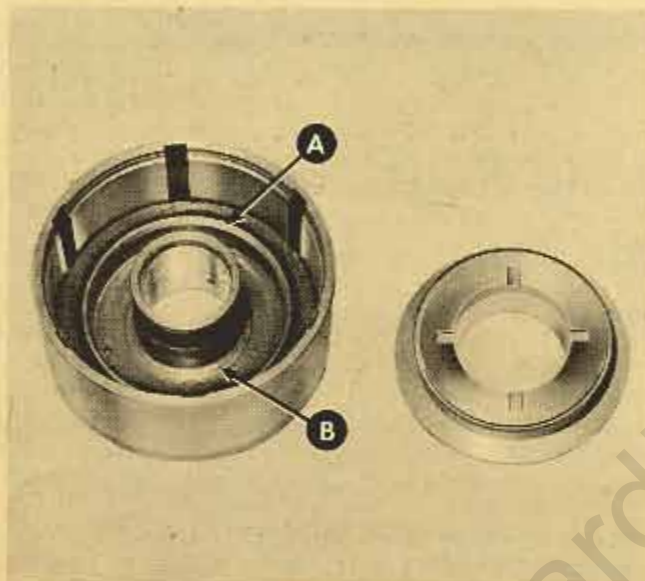
Engine runaway during low to high shifts has been reported on a few 55th Series cars, that could not be corrected by changing the throttle rod adjustment to raise the throttle pressure in the transmission.

In some instances, it has been found that the high range clutch piston in the released position rests on the milled surface indicated by "B" in the illustration restricting the oil pressure to the back of the piston causing slow engagement of the clutch.

When the piston is in its released position, the flange on the piston should rest on the shoulder "A" in the high range clutch housing, leaving .031" clearance between the end of the piston and the milled surface marked "B" which provides a means for the oil pressure to engage the clutch.

If the piston is found to be touching or resting on the milled surface "B" in the clutch housing, oil passages can be provided by filing four grooves in the piston as shown.

Using the edge of a 12" file, carefully file four grooves equally spaced 1/16" deep and 1/4" outward from the chamfered center hole in the piston.

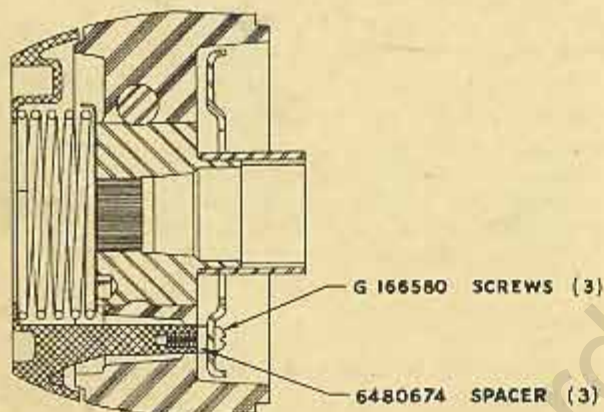
A few reports have been received of the horn button not making contact when the horn ring is pushed down at the location in line with the spoke of the steering wheel.

This condition can be corrected by installing spacers and longer screws between the steering wheel and the horn ring contact plate as follows:

2. Remove the three screws that attaches the contact plate to the steering wheel, install the three spacers No. 6480674 behind the plate and secure the plate with the three new longer screws No. G-166580. "See illustration."
