# SERVICE Counselor

PACKARD DIVISION

VOL. 30, NO. 3

MARCH, 1956

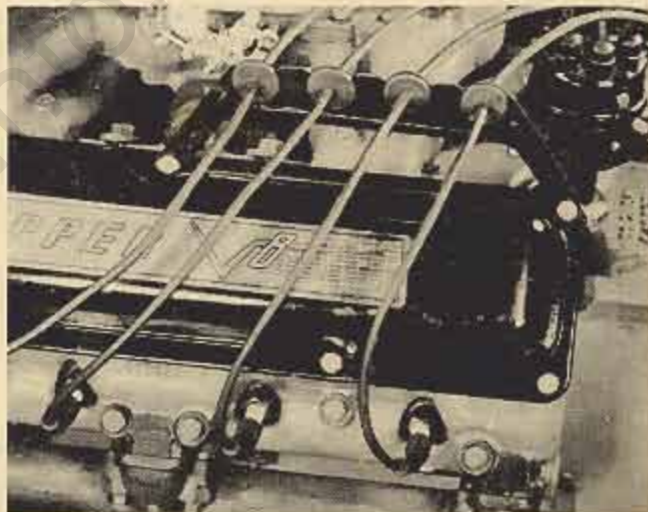
Occasional reports have been received of the V 8 Engine failing to respond smoothly on acceleration particularly in the 20 to 40 M.P.H. speed range. This condition is generally diagnosed as faulty carburetion, but in many cases it is caused by a cross-fire between No. 5 and No. 7 cylinders.

Cross-firing may be caused by pinched ignition cable wires between fingers of the cable supports breaking the wire insulation, separation of the dipped rubber from the cable supports or wires running parallel too close to one another for enough distance to permit capacitive coupling.

Should cross-firing occur, examine the ignition cables for broken insulation and if found satisfactory, install new ignition cable supports as shown in the illustration. The new supports spread the cables farther apart and the rubber grommets hold the cables at a greater distance from the metal supports.

1. Lift the ignition cables from between the support fingers on all four supports, remove and discard the cylinder head supports and the supports under the coil.

2. Install the new supports as shown in the illustration by attaching the supports under the center and rear cap screws for the rocker cover. Only one support is used per side.
3. Install the grommets on the cables and position the grommets in the supports leaving the cables at the approximate length shown.
4. It will be necessary to cut off some of the cables to obtain proper length between the support and the distributor cap. Remove the cables one at a time from the distributor cap, remove the cable terminals and cut off the amount of cable as listed and reinstall the terminal and cable in the cap.

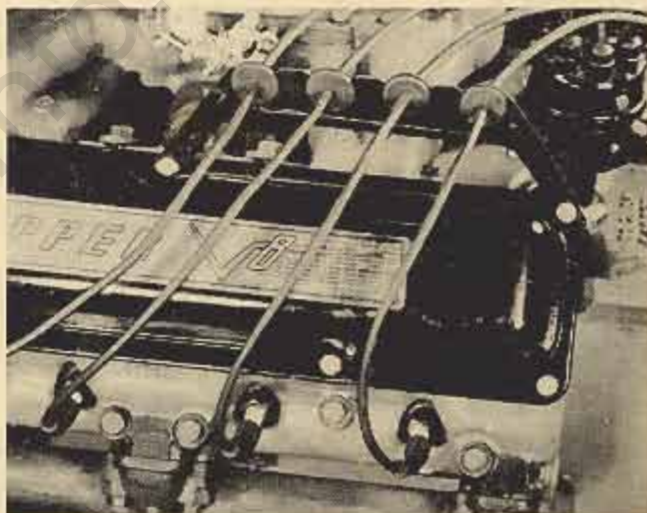
Occasional reports have been received of the V 8 Engine failing to respond smoothly on acceleration particularly in the 20 to 40 M.P.H. speed range. This condition is generally diagnosed as faulty carburetion, but in many cases it is caused by a cross-fire between No. 5 and No. 7 cylinders.

Cross-firing may be caused by pinched ignition cable wires between fingers of the cable supports breaking the wire insulation, separation of the dipped rubber from the cable supports or wires running parallel too close to one another for enough distance to permit capacitive coupling.

Should cross-firing occur, examine the ignition cables for broken insulation and if found satisfactory, install new ignition cable supports as shown in the illustration. The new supports spread the cables farther apart and the rubber grommets hold the cables at a greater distance from the metal supports.

1. Lift the ignition cables from between the support fingers on all four supports, remove and discard the cylinder head supports and the supports under the coil.

2. Install the new supports as shown in the illustration by attaching the supports under the center and rear cap screws for the rocker cover. Only one support is used per side.
3. Install the grommets on the cables and position the grommets in the supports leaving the cables at the approximate length shown.
4. It will be necessary to cut off some of the cables to obtain proper length between the support and the distributor cap. Remove the cables one at a time from the distributor cap, remove the cable terminals and cut off the amount of cable as listed and reinstall the terminal and cable in the cap.

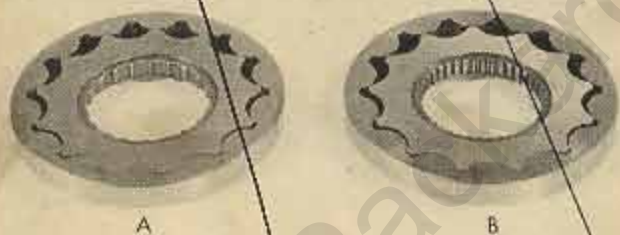
Fig. 1

"A" figure 1, shows the front oil pump rotor having 20 internal splines that is used in 54th Series Gear-Start, 55th and early 56th Series Ultramatic transmissions.

56th Series transmissions starting with serial numbers A-9681, B-6012, C-1143, D-1862 have front oil pumps with the direct clutch passage in the rear and also have the rotors with 40 tooth splines on the internal driving section, "B" figure 1.

Whenever worn or stripped splines are found on one of the units, always replace both units to provide proper spline mesh.

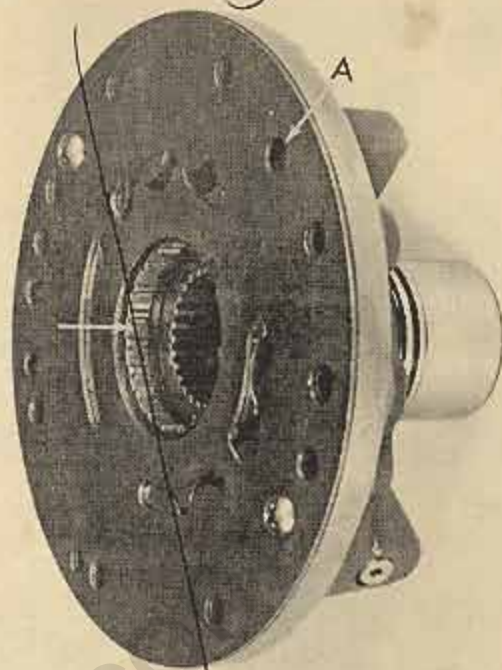
Fig. 2

On 54th Series Gear-Start, all 55th and 56th Series Ultramatic transmissions up to transmission serial number A-6481, B-4741, C-1057, oil pressure for the direct drive clutch came out of a passage on the front side of the pump. See "A" figure 2. The oil pressure is directed through a passage in the bell housing, then past the open splines in the rotor to the input shaft.

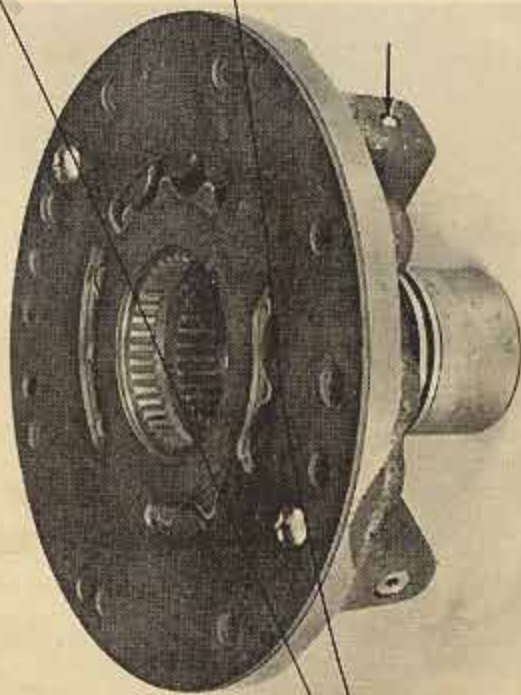
Fig. 3

56th Series transmissions after the above serial numbers have front oil pumps with the direct clutch oil passage in the rear side of the pump. "See arrow figure 3," also note the oil passage hole is not in the front plate. However, these pumps have the 20 tooth

splined rotors. (40 tooth rotor is shown in the illustration.)

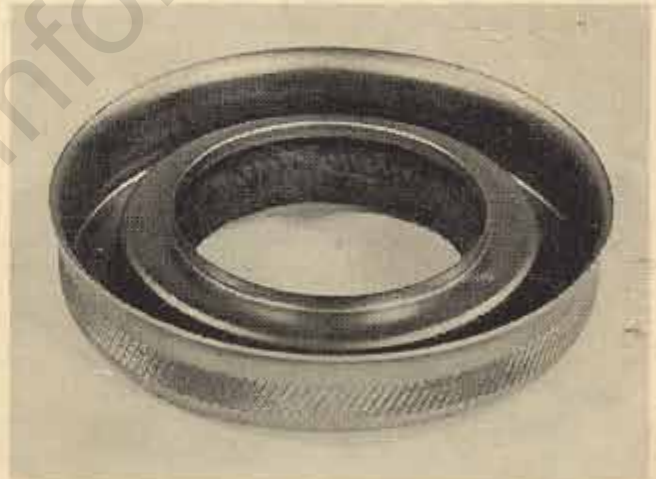
A few reports have been received of the front oil seal loosening and turning in the chain cover making it necessary to replace both the seal and cover to stop the leak.

Production is now using a seal with the outer diameter of the retainer knurled to prevent the seal from turning. "See illustration."

The new seal with the knurled retainer will press tightly into the cover even in cases where an old seal has turned.

When installing a new front oil seal, it is important that the instructions be followed as described on page 27 in the "Engine Section" of your Service Manual.
