PACKARD-CLIPPER DIVISION

STUDEBAKER-PACKARD CORPORATION

# Counselor

JULY, 1956

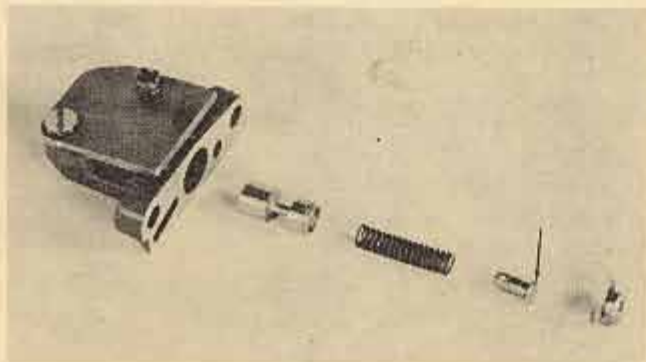
Occasionally an owner of a 56th Series Clipper may desire the transmission upshifts to take place earlier than is normal. Generally, the upshifts on the Clipper models, having 2.87:1 and 3.07:1 axle ratios, are somewhat later than on the Packard models having a 3.54:1 ratio.

Earlier upshifts on a Clipper can be obtained by increasing the tension of the high speed governor spring to raise the governor pressure. A suitable means of accomplishing this is shown in the accompanying illustration. Using a Manual Valve Inner Lever to Link Pin, Part No. 450692, slightly grind down the edge of the head (see arrow) so that it seats squarely in the spring seat. Install the pin in the seat end of the spring and reassemble the governor.

Raising the governor pressure in this manner will make the upshifts earlier in the moderate to full throttle range but will have practically no effect at very light throttle. Downshifts will not be affected appreciably except that the maximum "squeeze-off" point will be somewhat lower and less sensitive to throttle travel.

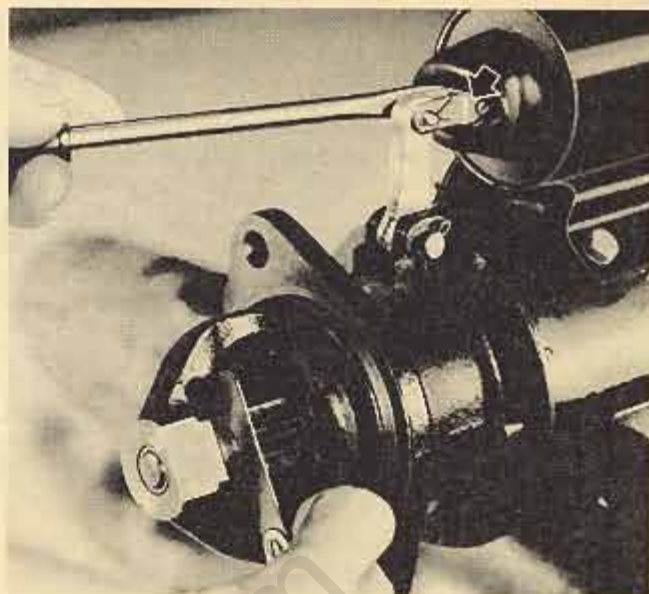
Pinion clearance must be adjusted correctly to obtain switch contact at the proper time in relation to pinion engagement with the flywheel, otherwise excessive wear may occur at the ends of the pinion teeth, flywheel teeth or the solenoid switch will not make contact.

To check Auto-Lite Starter Motor pinion clearance, use a screw driver and press the solenoid plunger inward—NOT THE FORK LEVER—until the plunger bottoms "See illustration". Measure the clearance

between the end of the pinion and the stop on the armature shaft.

The clearance should be  $\frac{3}{32}$  inch, plus  $\frac{1}{32}$  inch or minus  $\frac{1}{64}$  inch. Adjust for proper clearance by screwing the link in or out as required "See arrow".
