Studebaker

PASSENGER CAR SERVICE LETTER

NUMBER 936

SUBJECT ENGINE OIL PUMP RELIEF VALVE
TUBE KIT FOR CORRECTION OF
HYDRAULIC VALVE TAPPET
LETDOWN - 56J GOLDENHAWK

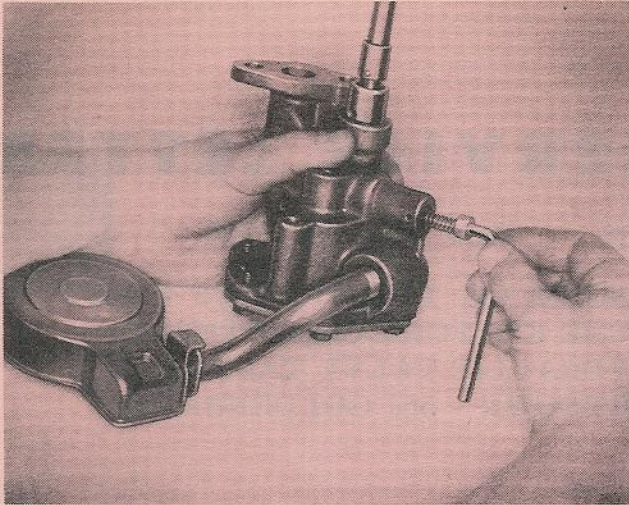
FIG. 1

Hydraulic valve tappets that intermittently become noisy at idle speed or at speeds of 40 to 60 M.P.H. after the oil gets hot in most cases has been caused by air getting into the oil pump and gallery thereby interrupting the oil supply to the tappets.

5. Install the relief valve and spring, start the flanged end of the tube in the housing with small end of tube pointing downward. (Toward bottom of pump). (See Fig. 1).

Carefully drive the tube into the housing with the back side of flange just past the cotter pin holes. A tool can be made up locally for driving in the tube by using a small steel sleeve that will fit in the relief valve opening and cutting a slot in the side of the sleeve so it will straddle over the bend of the tube.

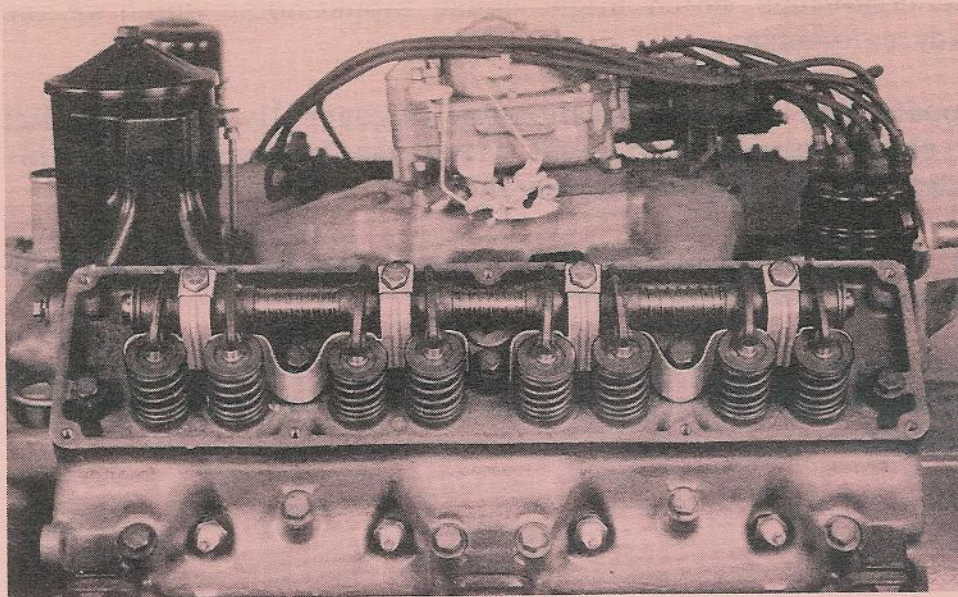
FIG. 3

When installing the oil pump tube kit on cars with engines prior to K-1150 and S-2064, the valve spring baffle kit Part No. 6484396 should be installed. This is important for oil consumption control as noisy tappets will develop if the oil level gets too low. At the same time the possibility of oil fouling of spark plugs will be greatly reduced or eliminated.

- B. Position the baffles on rocker assembly, lining the bolt holes on baffle with bolt holes on rocker brackets. (See Fig. 3). Replace rocker assembly on cylinder head. Replace the rocker shaft bolt lockwasher with the square type lockwasher. Install the rocker shaft bolts, make sure the push rods are

in the sockets of the levers and torque tighten the rocker shaft bolts 55 to 60 ft. lbs. Be sure the square lockwashers do not turn with the bolt, as the baffles might be distorted.

- C. Check clearance between the baffles and the valve springs. If touching, bend the baffle away slightly with a screwdriver. Install the rocker cover using new gasket.
- D. Do not remove the intake valve rubber oil deflectors.
