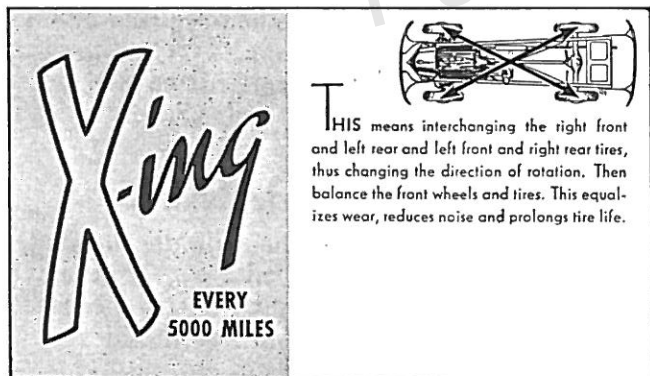
An entirely normal but little understood form of tire wear is that in which one edge of the tread buttons wears faster than the other, creating a saw-tooth effect referred to as heel-and-toe-wear.

The end of the tread button that wears the fastest is the one that grips the road first when the brakes are applied. High speed driving and excessive use of the brakes will cause this type of irregular wear.

Heel-and-toe wear occurs on any type of non-skid tread design. It is less on rear tires because the driving force wears down the opposite ends of the buttons, tending to equalize the wear.

Although heel-and-toe wear is an entirely normal condition it may cause your owners to believe there is some misalignment in the steering system. Some unscrupulous operators of steering alignment equipment use this condition of tire wear as an excuse to sell needless but expensive steering alignment operations.

X-ing the tires, i.e., interchanging the right front and left rear and left front and right rear, will change the direction of rotation of the tires and equalize the wear. Wheels and tires should be interchanged without dismounting the tires. When interchanging, be sure the ones put on the front wheels, including tires, tubes, wheels and hubs, are in balance.

It is recommended that tires be interchanged in this manner regularly at approximately five thousand-mile intervals.

Irregular front tire wear may cause tire noise. If tire noise should develop, the tires should be interchanged as described. The noise will not be eliminated immediately, but will disappear when the wear is again even. To prevent this type of noise interchange after they have been driven two or three thousand miles.
