PACKARD

Service Counselor

VOL. 21 NO. 9

JUNE 1, 1947

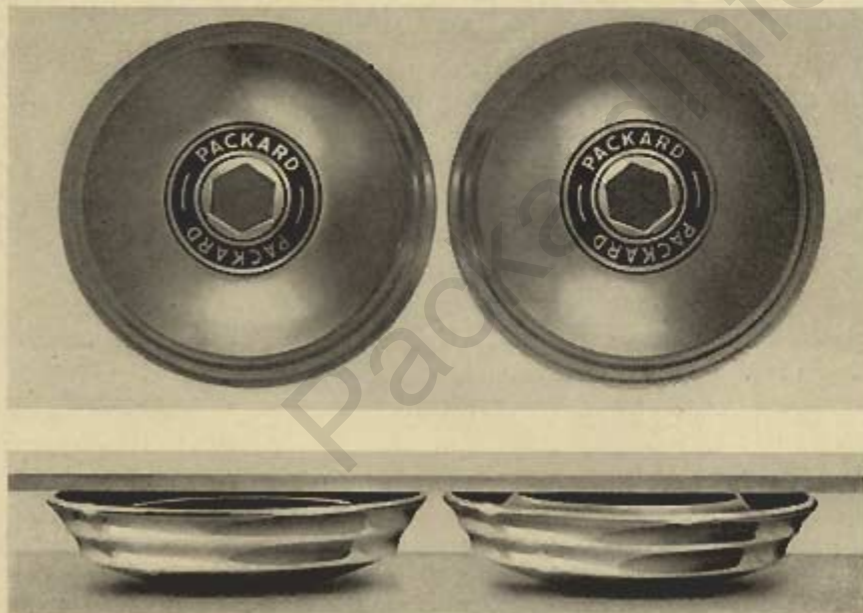
Occasionally we hear reports of hub shell covers being lost or thrown off wheels when a car is driven over a fairly deep rut or over objects which suddenly jar the wheels.

Hub shell covers also can be lost if they are not installed on wheels for which they were designed. The accompanying illustrations show the difference between a cover for the 2103 model and one for the 2111 model. Externally, there is no difference. Internally, however, the difference is very pronounced.

As you will note, the bead around the inner shell of the cover for the 2103 is almost flush with the outer edge of the cover, while the bead in the 2111 cover is approximately $\frac{1}{2}$ inch below the outer edge. If the cover for a 2111 were installed on a 2103 wheel, the bead around the inner shell would set on top or just barely pass over the peak of the ramp on the spring clips. A short trip over a "wash-board" road probably would find this cover among the missing. On the other hand, if the 2103 were installed on a 2111 wheel, the cover could be fully seated but would present a poor appearance since the outer edge of the cover would stand out quite a distance from the wheel.

2111

2103

In the majority of cases, this condition is the result of the cover not being properly installed or, in other words, not being fully and evenly seated over the five spring steel retaining clips on the wheel.

Installing the proper cover properly will save covers.

When installing a hub shell cover, the cover first should be centered over the five retaining clips and then pressed on evenly so that all the clips are flexed at the same time. Proper seating can be checked by
