PACKARD

Service Counselor

VOL. 21 NO. 2

JANUARY 15, 1947

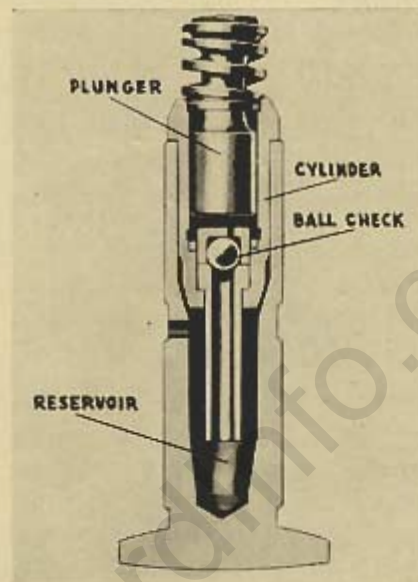
As shown in the illustration, the hydraulic unit is set into a hollow mushroom type tappet which contacts the camshaft. The unit itself consists of the cylinder, incorporating an inlet tube and a ball check valve, and the plunger and spring assembly. The plunger and cylinder are highly machined and are fitted to very close limits.

When hydraulic tappets become noisy, there are two possible causes:

(1) When one or more tappets are noisy, the usual cause is dirt between the plunger and the cylinder or under the check valve ball.

(2) When all lifters are noisy, the usual cause is an insufficient supply of oil reaching the tappets.

If both the main oil system and the tappet oil system show correct pressures and some of the tappets are noisy, the trouble lies in the tappet assemblies. Dirt between the

plunger and cylinder or under the ball check will either prevent the tappet from filling with oil or will permit the oil to be forced out when the valve is lifted.

A tappet whose plunger sticks may be freed up by raising the valve spring and prying the plunger up with a screw driver. The screw driver should be carefully inserted between the coils of the spring. Once freed, hold the base of the tappet and rotate the plunger to work out the dirt or foreign substance that caused the sticking. Always rotate the plunger clockwise, which is the direction in which the spring is wound. This is not a sure-fire method but it is worth trying.

When the plunger of a noisy tappet is not stuck but may be pushed down by hand, the check ball in the cylinder is not seating properly. This condition makes it necessary to remove the cylinder head and remove the faulty unit.

Remove the plunger from the unit and thoroughly wash and dry both parts. In most cases the particle of dirt that causes failure of a unit is so small that it cannot be readily seen with the naked eye but will be removed by washing in clean kerosene. Reassemble the unit by inserting the plunger into the cylinder. The ball check should be air tight causing the plunger to "bounce" when it is suddenly pushed into its cylinder. If the plunger "bounces" indicating that the ball is seating, turn the unit upside down and push the plunger in while twisting in the direction in which the spring is wound. A snap will be noted when the spring drops into its seat.
