PACKARD

Service Counselor

VOL. 21 NO. 9

JUNE 1, 1947

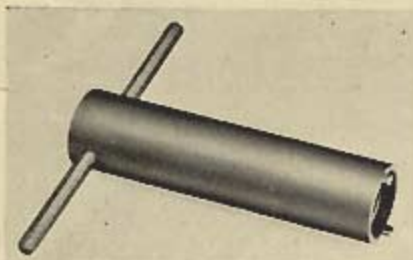
A MAP LIGHT SWITCH WRENCH—All Clippers

In answer to field requests a wrench has been designed for the removal and replacement of the Clipper map light switch.

This wrench may be ordered from the Kent-Moore Organization under catalog No. J-1588, Map Light Switch Nut Wrench. The list price is \$1.25.
