# SERVICE Counselor

PACKARD MOTOR CAR COMPANY

VOL. 25, NO. 6

JUNE, 1951

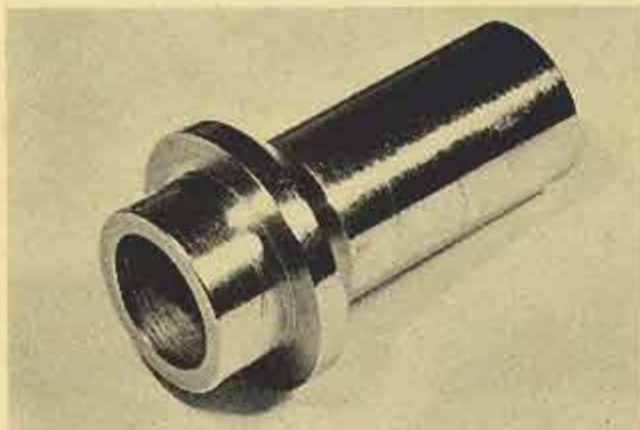
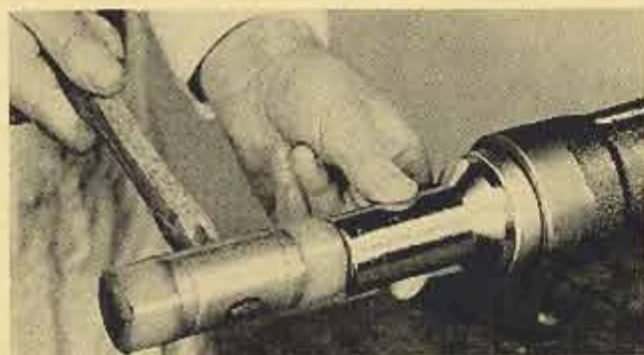
PU-367

The Rear Housing Oil Seal Replacer, for the 24th Series Ultramatic Transmission, provides a quick, easy and safe method of replacing the oil seal. This tool permits the mechanic to drive the oil seal straight into position and to the correct depth, with less danger of damage. Correct installation is also assured in the prevention of oil leaks.

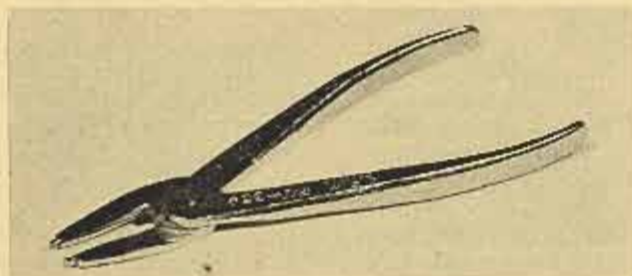
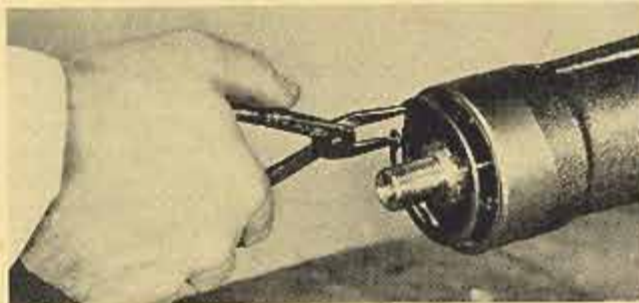
PU-369

The Retainer Ring Pliers permits the removal and replacing of the retainer ring for the ball bearing in the rear housing of the 24th Series Ultramatic Transmission. There is no danger of damage to the ring or other parts when these pliers are used.

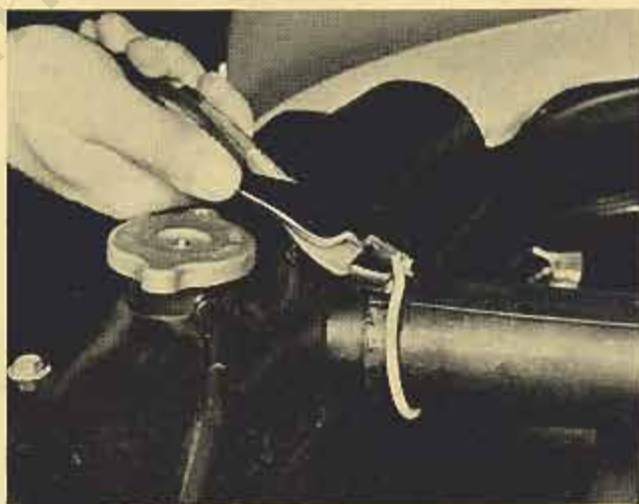
PU-370

These special pliers provide a safe method to remove and replace the spring type hose clamps used on the radiator and heater hoses. This tool eliminates the danger of slippage with its resultant damage.
